AVIATION INVESTIGATION REPORT
A17Q0050

Collision with wires

Exact Air Inc.
Piper PA-31, C-FQQB
Schefferville Airport, Quebec, 3.5 nm NW
30 April 2017

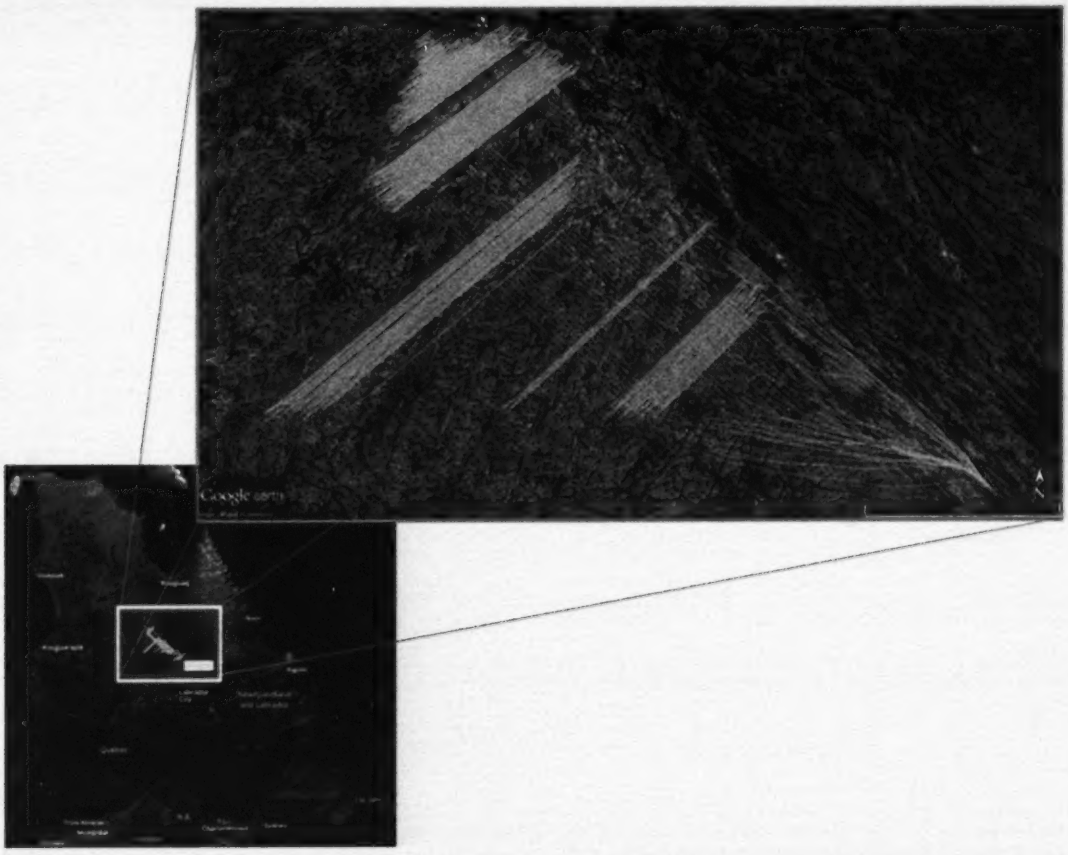
Figure 1. Flight paths over a 7-day period representing survey areas and flight segments between the operating base and the survey areas of the occurrence aircraft (Source: Google Earth, with TSB annotations)

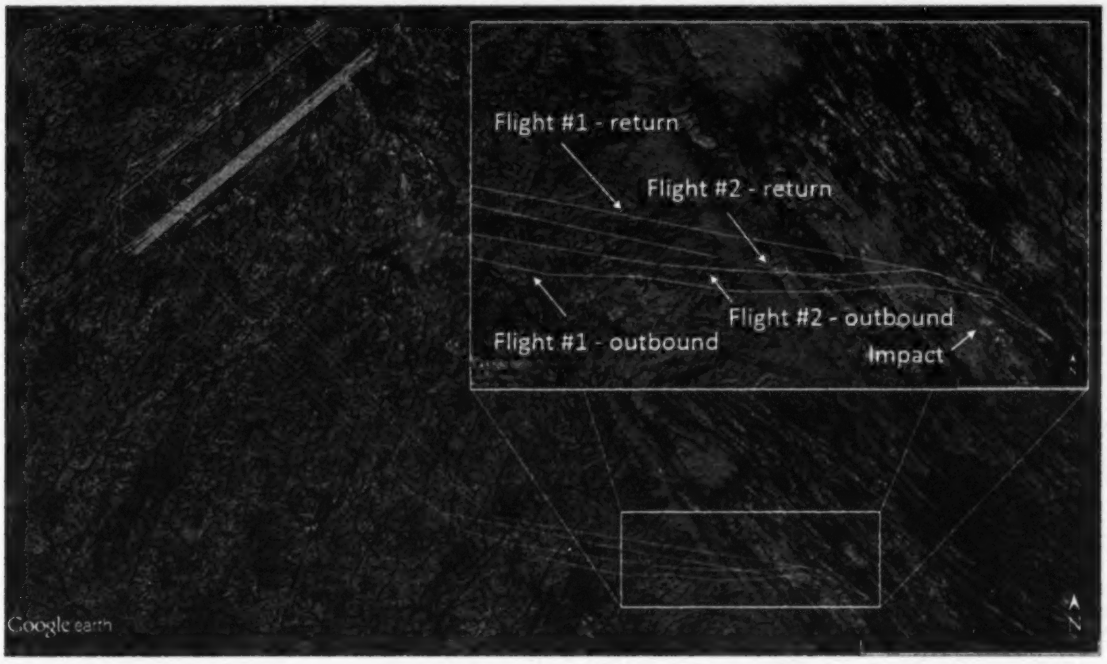
Figure 2. The 2 flights conducted by C-FQQB on the day of the accident, with detail showing the very-low-altitude flight segments (Source: Google Earth, with TSB annotations)

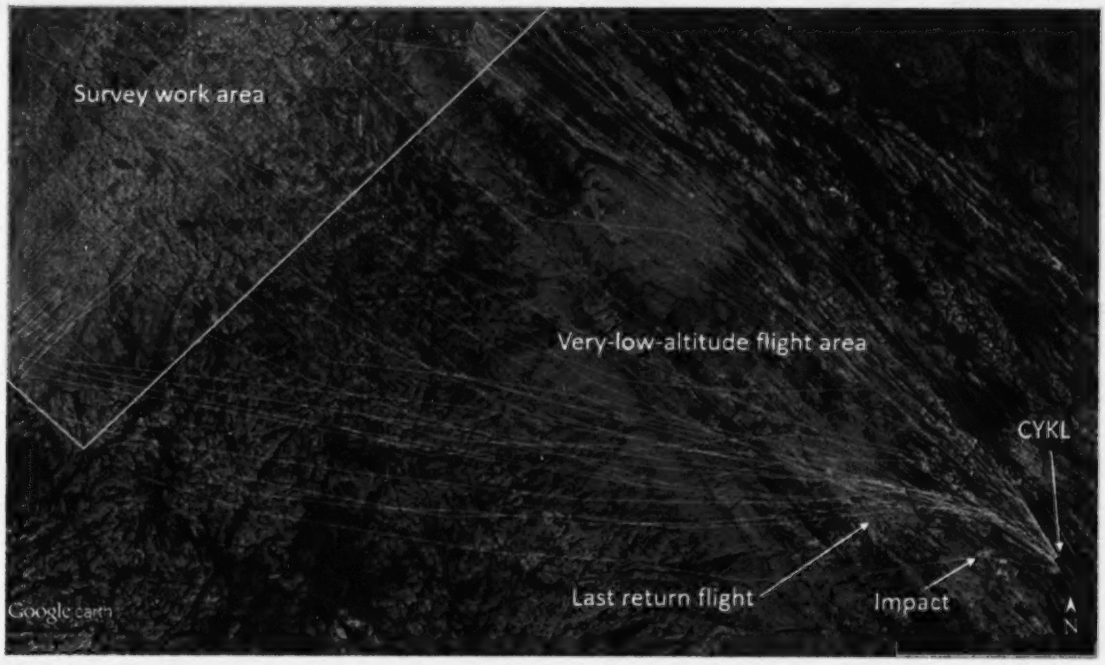
Over a period of 19 days before the accident, the pilots had conducted 21 magnetometric survey flights at low altitude. During these flights, analysis of GPS data shows that the occurrence pilots had conducted 27 segments of flights involving very-low-altitude flying (less than 100 feet AGL) during round trips without incident (Figure 6).

Figure 6. Very-low-altitude flight zones in the 19 days preceding the accident (Source: Google Earth, with TSB annotations)

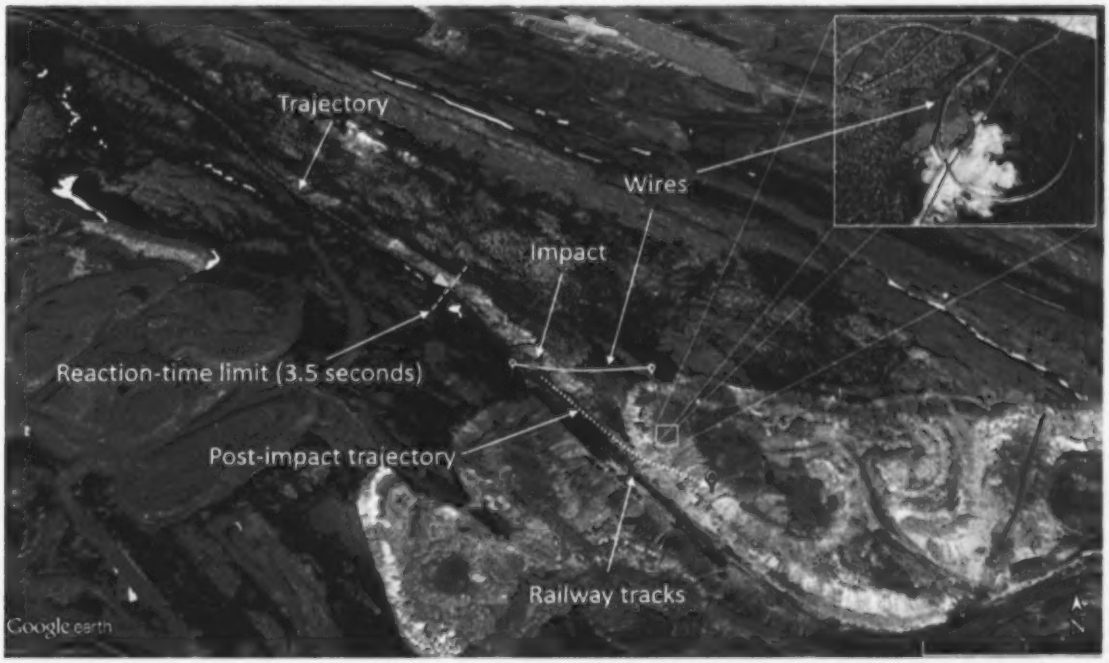
The mines operated in the area where the accident occurred were iron mines, and the mine tailings deposits there gave the terrain a reddish tint typical of iron oxide. In addition, the conductor cables were dusted with the same colour, reducing their contrast with the surrounding terrain (Figure 7). There was also very little contrast between the wooden pylons and the terrain. At the time and place of the occurrence, the top of the mine tailings deposit was about 75% covered in snow, but the sides exposed to the sun and the runoff water were free of snow.

Figure 7. Occurrence aircraft path immediately prior to impact (Source: Google Earth, with TSB annotations)

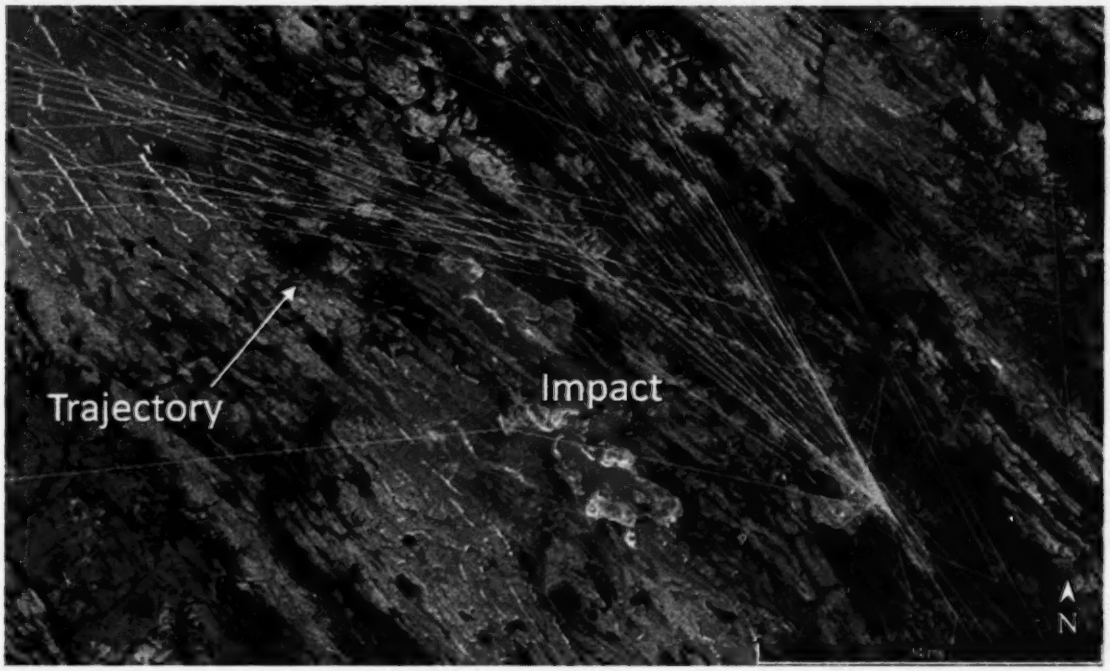
Because magnetometric survey flights are conducted at low altitude, the crew had conducted a reconnaissance flight over the survey area to identify potential hazards; however, reconnaissance was not required for the outbound and inbound segments, and the investigation determined that no flight over the accident site had been conducted (Figure 8).

Figure 8. Area of the occurrence aircraft's last very-low-altitude flight (Source: Google Earth, with TSB annotations)

The power transmission line was not depicted on the chart, the wires were not marked, and no reconnaissance flight had been conducted. As a result, it is highly likely that the pilots were unaware that there was a power transmission line in their path.

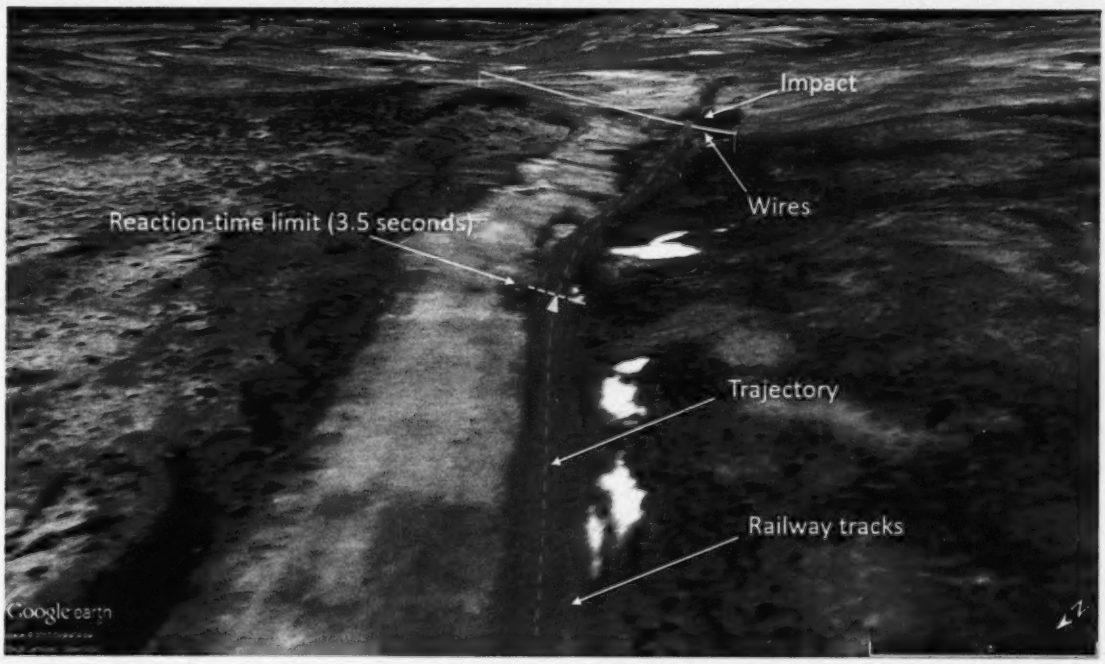
As the aircraft was approaching this limit, the pilot had to turn right to remain above the railway tracks, creating a situation that was not conducive to a longer-distance visual scan to detect the wires. During the turn, the aircraft passed the point (Figure 9) at which there was insufficient reaction time to avoid the wires.

Figure 9. Trajectory prior to impact (Source: Google Earth, with TSB annotations)

Consequently, as the aircraft was flying at very low altitude above the railway tracks, the pilot flying did not detect the power transmission line in time to avoid it, and the aircraft collided with the wires, which were 70 feet above the ground.
